Advisory Visit

River Devon

01/10/2019

Undertaken by Gareth Pedley (WTT)

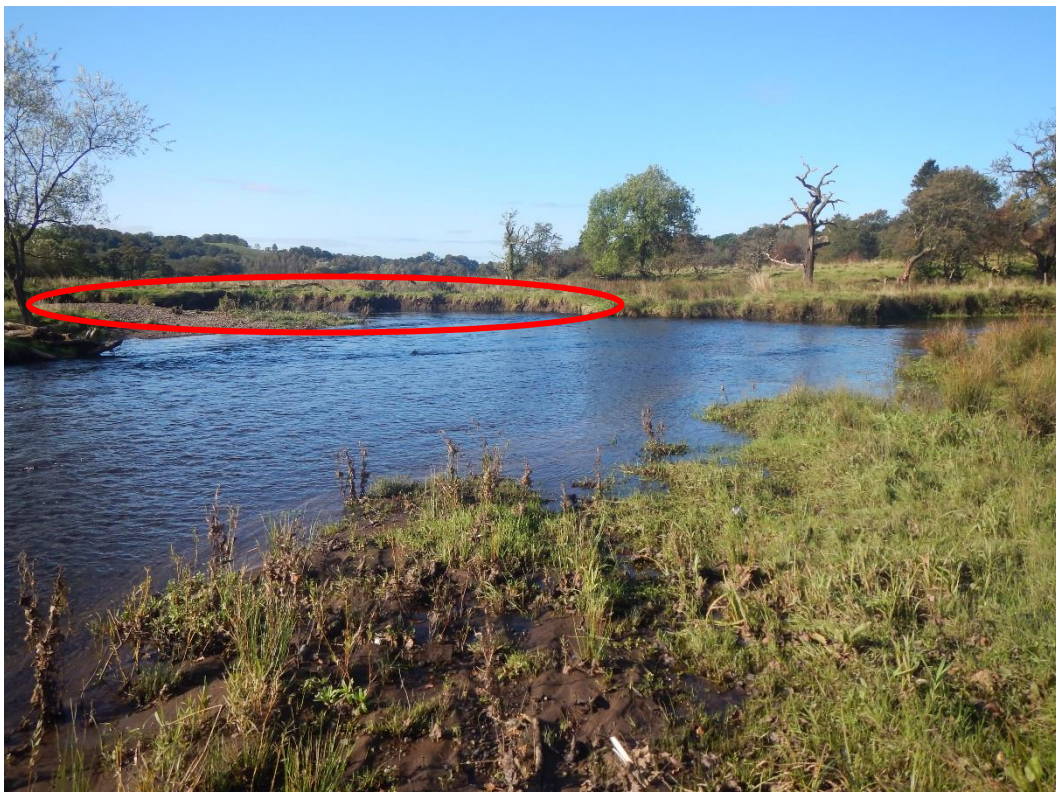
At the downstream limit inspected (around Tait's Tomb), cattle have access to the watercourse and there is an impact from grazing upon the abundance and diversity of bankside vegetation. Although the stock density did not appear to be excessive, it was limiting natural tree and shrub regeneration, with only mature trees and heavily browsed saplings present. This reduces the riparian habitat quality for invertebrates and other wildlife but allows increased erosion by reducing the extent of root structure within the riverbank; something that was particularly evident on the sharper bends (Fig. 1). Erosion is not necessarily bad, but when occurring at accelerated

rates it oversupplies soil and fine sediment to a river. This can block the spaces between coarser bed material and limits the habitat quality and availability for invertebrates. The restriction of water flow through the bed, also reduces its value for salmonid spawning as incubating eggs laid within the gravels/cobbles require a supply of oxygenated water.

Figure 1. Livestock grazing is reducing species diversity on the banks and facilitating areas of accelerated erosion (red ellipse).

Fencing off the watercourse would allow a vegetated buffer strip to establish and would improve riparian habitat quality. This would require the farmers relinquishing a strip of land from grazing, but it would help to stabilise the channel, ultimately to their benefit, especially if tree planting is undertaken within the strip to help bind the bank together. Confining the livestock to one or other side of the river may provide additional benefits for the farmer. The Woodland Trust can often supply trees free of charge if suitable locations can be found in which to plant them (see Recommendations).

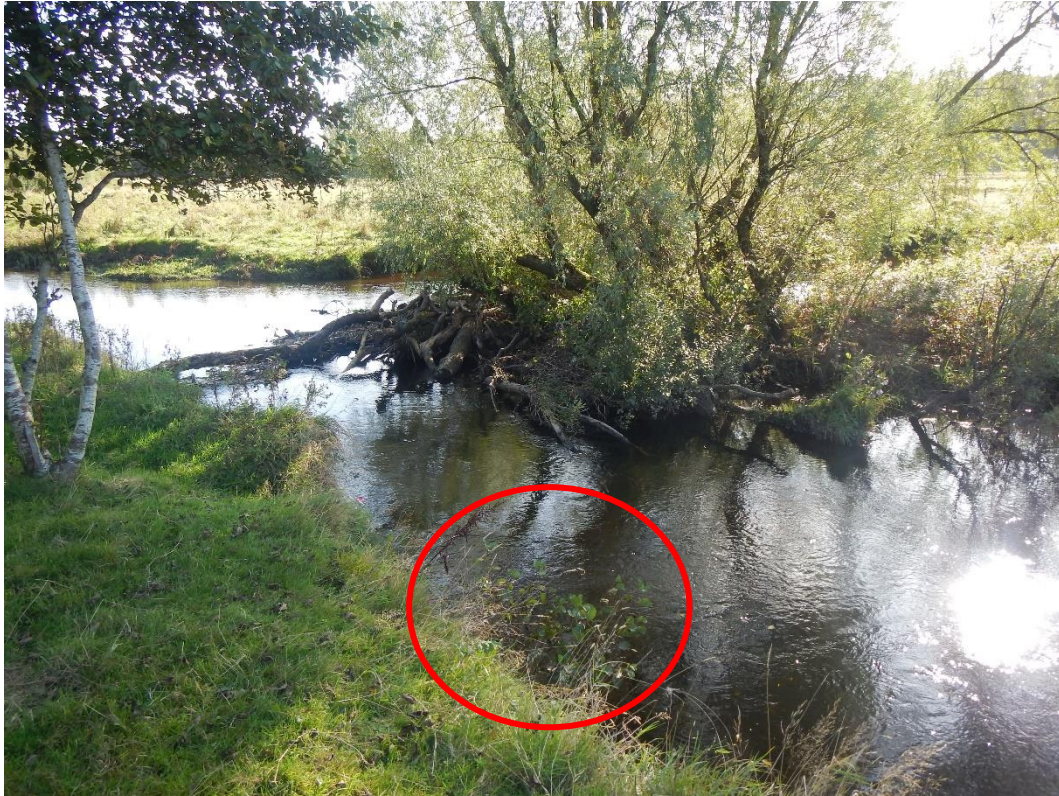
In areas where bankside trees are present they create high quality habitat, particularly where low branches trail into the river, providing cover and structure that will protect the fish from predators and offer respite from high flows. These features are particularly valuable where they encourage wood-jams that diversify flow and create scour to develop deeper pools. The greater variety of habitat niches created increase the number and size of fish that an area can hold. While some may see in-channel structure as an obstruction to angling, the habitat benefits and increased angling opportunities they provide far outweigh any inconvenience.

Figure 2. High quality habitat created by trailing branches, with the area further enhanced by an accumulation of woody material. The urge to remove or alter this type of habitat should be resisted. Note the small alder sapling that has managed to establish (red circle) just out of livestock reach, but little more than short grasses in the accessible area to the left.

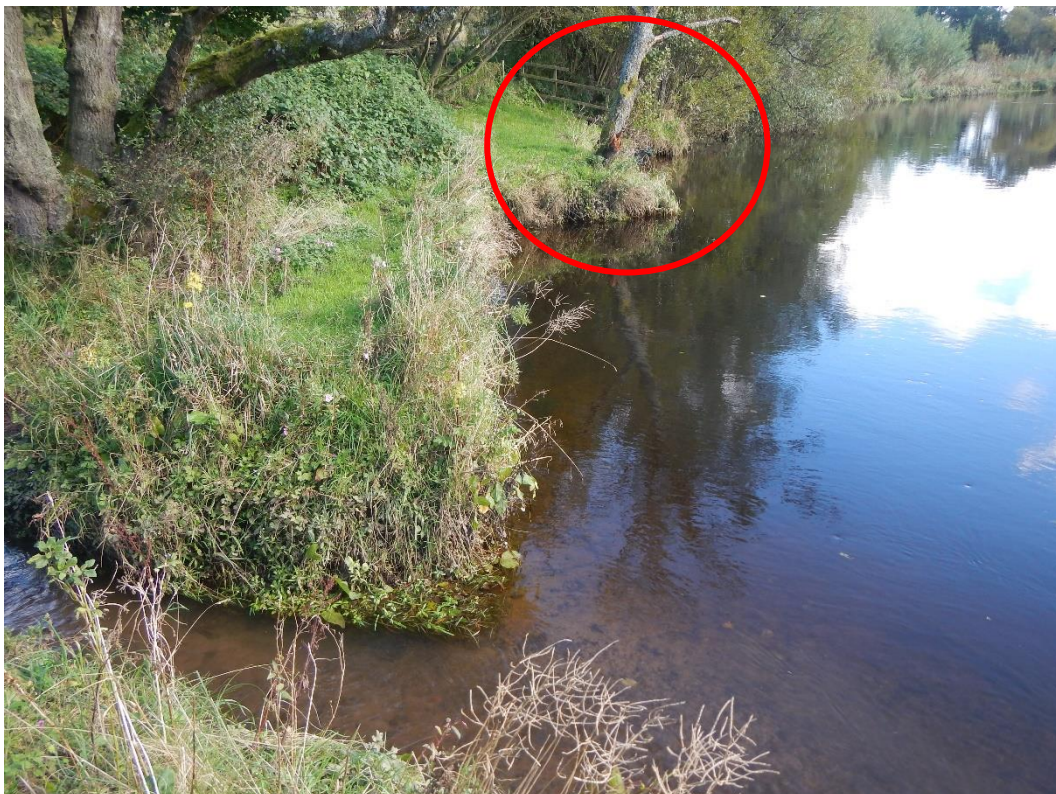
Figure 3. It is unclear whether the short grass here is due to strimming or livestock access, but it would be beneficial to maintain more of the valuable riparian fringe, further back from the river. Coppicing the tree in the background (red circle) could prolong the tree's life by preventing it from toppling into the river (taking a chunk of bank with it), while also reinvigorating the tree with low-level regrowth.

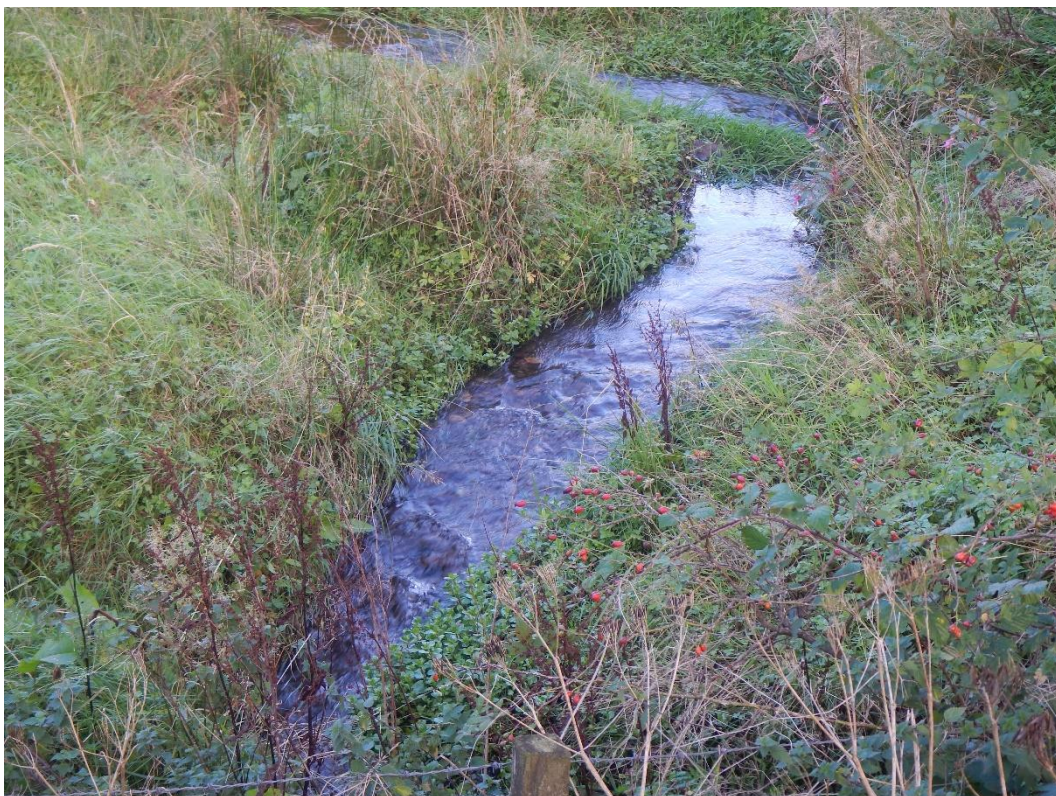
A small burn enters the river at NS 94015 97360, offering potential salmonid spawning and juvenile habitat, although it appeared to carry a high load of sand and fine sediment, as evident by the change in water and bed colour (Fig. 3). It would be worthwhile identifying the fine sediment source as addressing the issue could improve its potential for juvenile production. It was not possible to ascertain whether the grass in this area has just been grazed or possibly also strimmed. either way, the lack of vegetation degrades the bankside habitat. Again, excluding livestock would be beneficial. If vegetation maintenance is undertaken to improve access, it is best to create a main access track well-back from the bank top, with occasional routes leading to the watercourse, thereby maintaining the valuable riparian fringe for invertebrates and other wildlife. An old alder tree leaning over the river here could be coppiced to encourage valuable low-level regrowth and reduce the risk of it toppling (Fig. 3).

Figure 4. The small tributary at NS 94015 97360 appears to offer good potential as a spawning/juvenile area, providing fine sediment inputs can be prevented. Maintaining a well-vegetated riparian zone in all areas (resembling that shown here) would ensure high quality habitat.

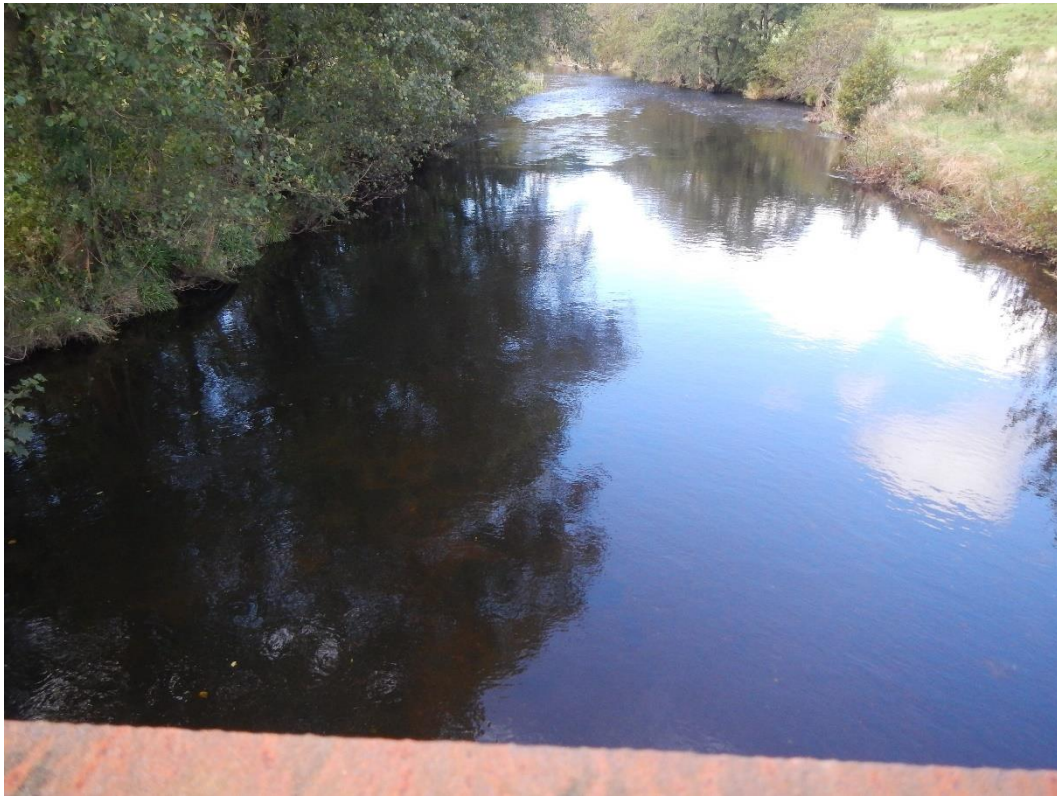
The next area inspected was at the metal bridge (NS 94975 97580), a short distance downstream of the Dollar sewage treatment works. Downstream of the bridge, habitat quality is good, with a healthy diversity of bankside trees and vegetation providing low/trailing cover and shade. The in-channel habitat is a little open and would benefit from more structure like low-hanging/trailing branches or large woody material. Again, the urge to tidy the river should be avoided and any such material that occurs should be left in place.

Figure 5. Good riparian habitat, although the in-channel habitat would be improved by additional structure, as observed upstream of the bridge.

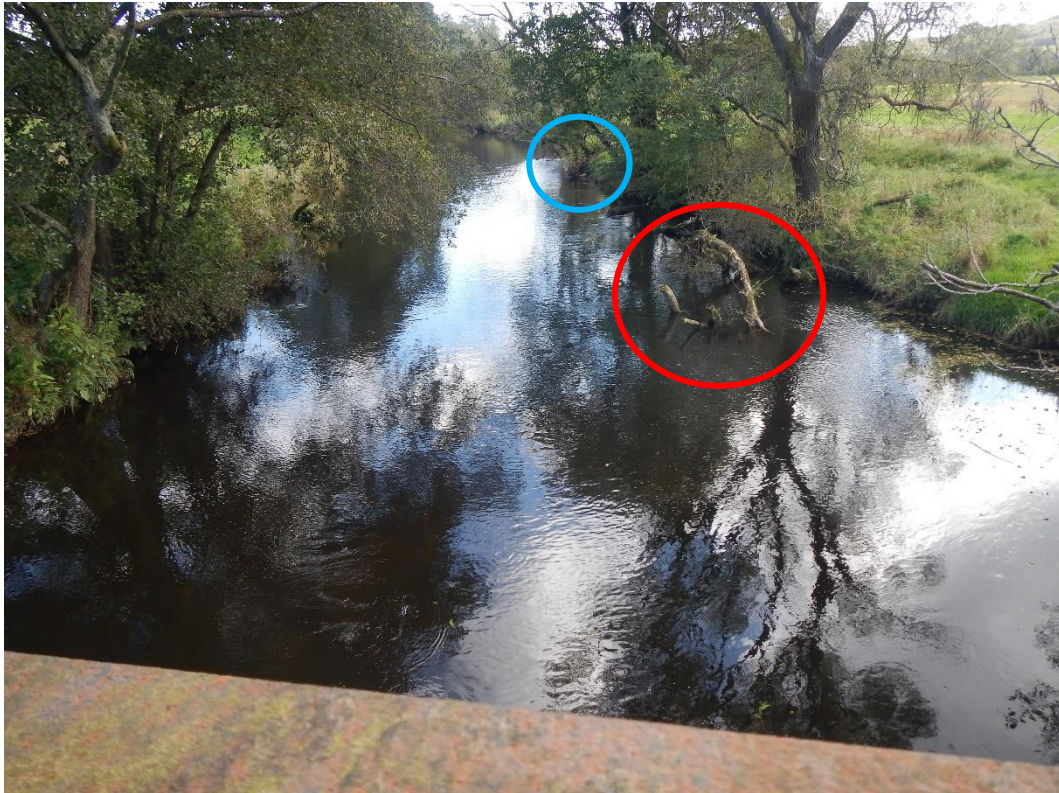
Upstream of the bridge, the bankside habitat is similar, but with more woody material in the channel, increasing flow diversity and providing additional fish-holding features (Fig. 6). Some of the original material has clearly been removed, as evident by the angular saw marks on the branches, but the remaining branches diversify what would otherwise be relatively featureless, open water. There is always a trade-off between providing fishing access and maintaining high quality fish habitat, but it is invariably better to retain the maximum amount of habitat possible and work out how to fish around it, rather than removing the features that hold the fish in the first place. Retaining these features (and even encouraging them to develop) will increase the number of fish a river can hold (be they resident or migratory) but also, equally importantly, the range of areas fish will hold, thereby spreading the angling opportunities and pressure throughout the fishery.

Figure 6. The pool habitat upstream of the bridge is greatly improved by the structure the fallen tree/branches (red circle) and low, trailing branches (blue circle) provide.

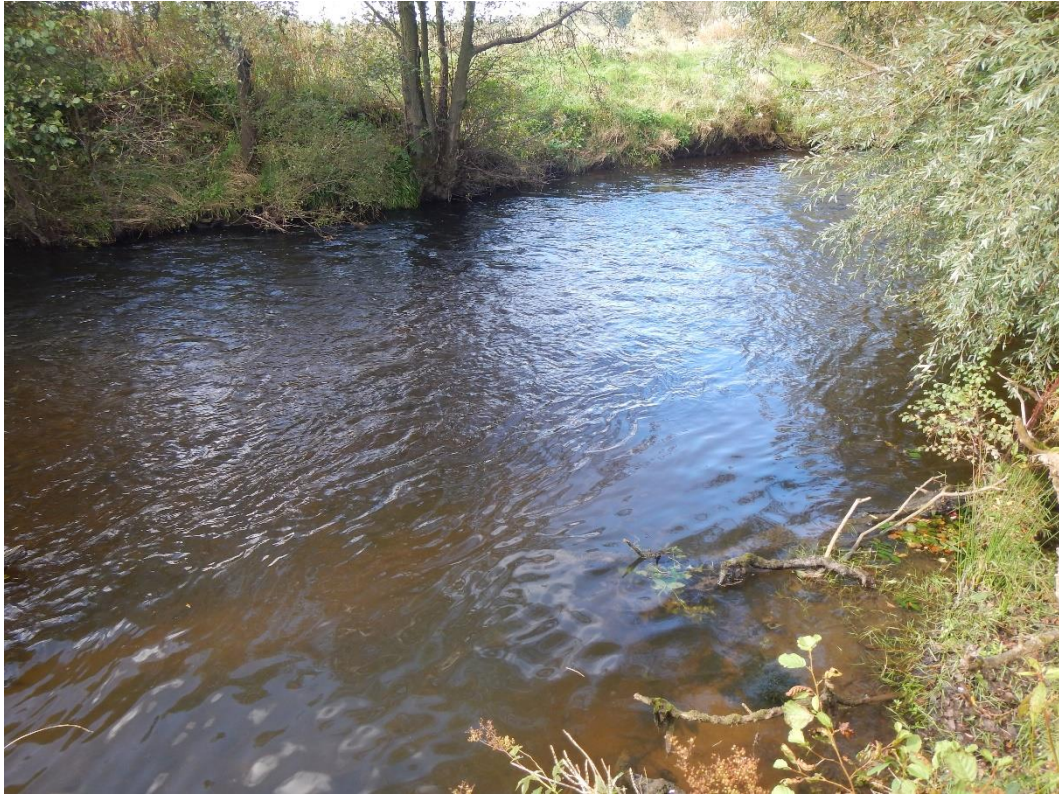
At the sewage treatment works outfall, a slight odour and obvious discolouration of the river water, strongly indicative of poor water quality. This was supported by the presence of elevated algal growth and sewage fungus on some of the in-channel woody material. The discharge is very likely to be contributing to the WFD failure for phosphorus.

Figure 7. Water discoloration (foreground) and signs of enrichment at the sewage works outfall.

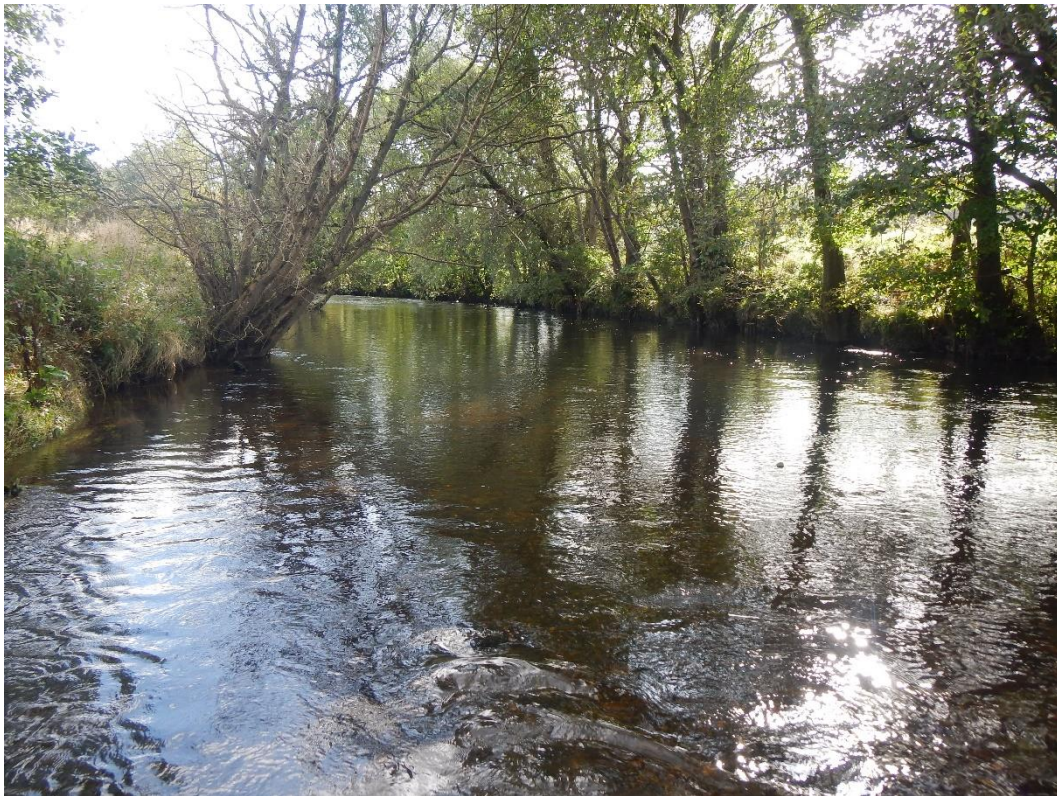
Upstream of the sewage outfall (around NS 95217 97485), the uniform age class of the trees, coupled with the loss of low branches, has resulted in a relatively high canopy that casts uniform shade (Fig. 8). While the habitat observed is certainly not bad, coppicing the occasional tree (one in every five or so) could let more light to the channel and encourage low-level regrowth from the stool that would develop valuable fish cover. Some of the material generated could be cabled or lodged among the remaining trees or stumps to provide additional woody material, increase flow diversity and provide additional fish lies.

Figure 8. Good general habitat quality, although it could be improved by very selective coppicing to diversify the canopy and encourage an increased density of low-level branches.

In areas where numerous uniform height/age trees line the bank (as in Fig. 8), coppicing one or two trees could reinvigorate low-level bushy regrowth and increase the availability of fish cover. This should ideally be undertaken within the dormant season to reduce the impact upon the tree and to nesting birds.

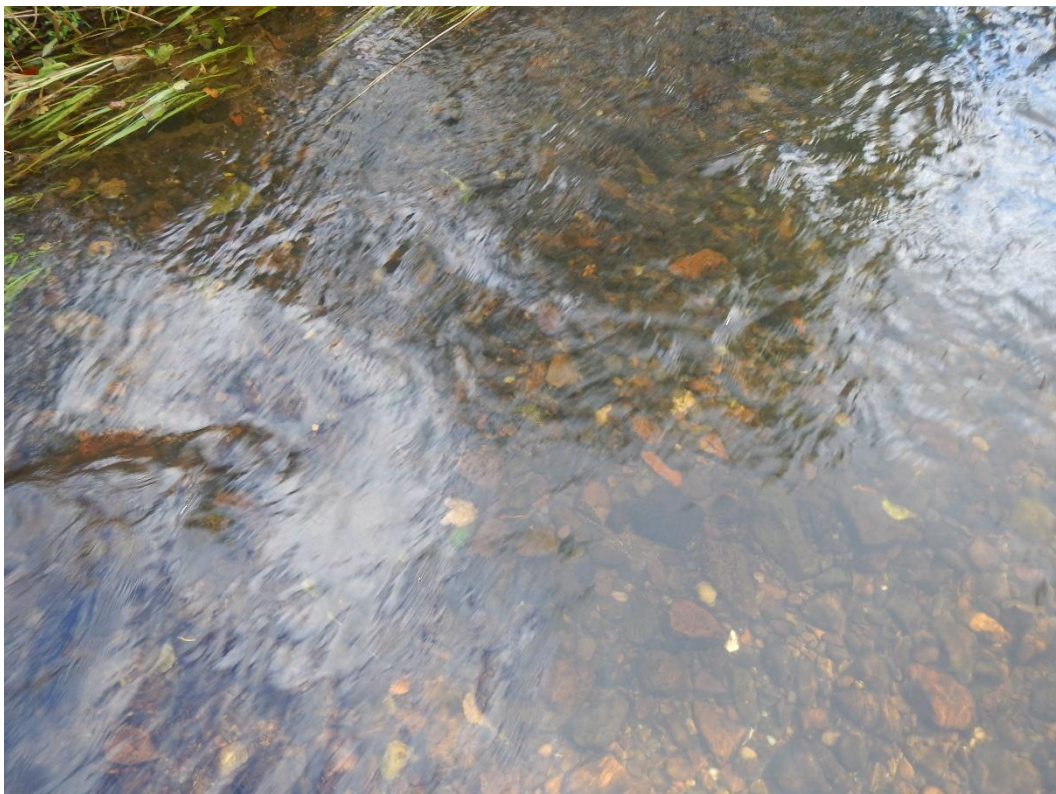
The substrate quality in the area around the sewage discharge is generally good, providing habitat for invertebrates and potentially salmonid spawning, particularly for larger migratory fish. River resident trout tend to utilise 10-40mm gravels in which to cut their redds, so generally spawn in smaller, lower energy tributaries but being larger, migratory salmonids tend to use 20-60mm+ gravel and cobbles, and often also use the main river channel for spawning. The value of any spawning areas can be increased by ensuring that there is ample cover and structure within the river margins downstream in which fry can find refuge. Scruffy river margins with trailing branches and vegetation = good salmonid habitat.

Figure 9. Well-sorted substrate, relatively free from fines. Many areas of the main river channel offer potential for migratory salmonid spawning. Even resident trout will use areas of the main channel but often favour the smaller tributaries, so they also require protection.

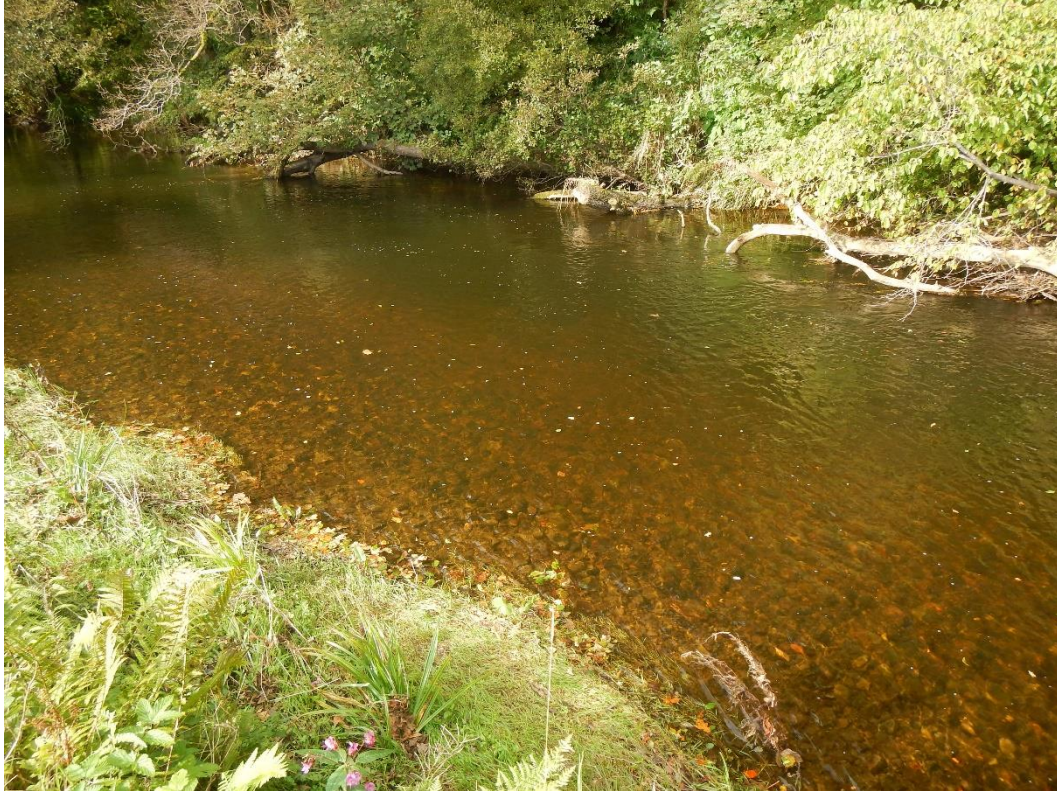
Fallen trees at a deeper bend create great cover for fish and contribute to the development and maintenance of high-quality habitat (Fig. 10). The increased flow diversity around the structures provides additional food lanes and lies for fish and will create bed scour at high flows contributing to a more varied pool, both as habitat and for fishing.

Figure 10. A great example of the enhancement that woody material can create to the habitat quality of a pool. More features like this (and even more extensive) throughout the river would increase the number of areas in which larger fish will hold.

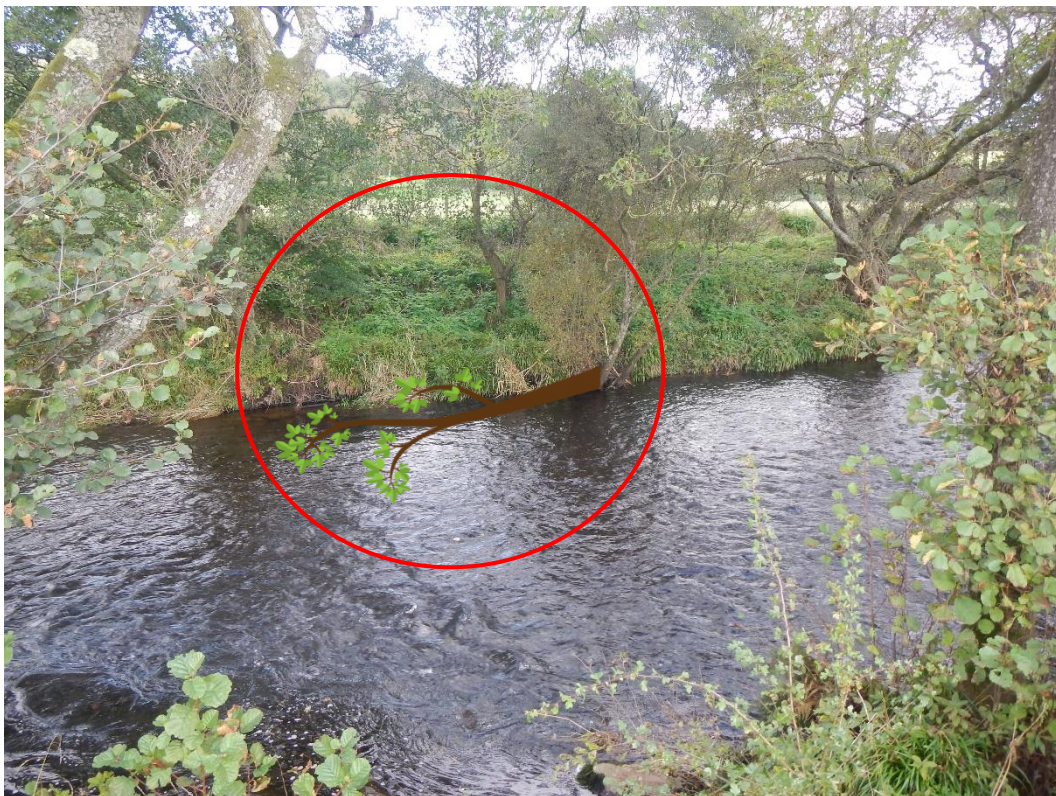
To replicate some of the in-channel structure in Figure 10, the willow tree highlighted in Figure 11 could be laid down along the bank, or even into the water. Other willow shrubs and pliable tree species (hazel, thorn and elm) along the river could be treated similarly, although it is only willow that will thrive with its canopy partially submerged. Care should be taken to only lay the occasional tree so as not to create too much of one type of feature and a negative impact upon habitat diversity.

Figure 11. The willow in the centre of shot (NS 97937 97841) could be laid down along the bank in a downstream direction to provide cover and structure within the channel. Ideally, the trees used for this technique would already be leaning downstream (the direction they are best felled), but if cut in the right place, it should be possible to lay the tree round to a downstream direction. In the unlikely case that it snapped off, the low regrowth from the stump would still be beneficial and the trunk could be pinned elsewhere.

Laying the occasional suitable tree species down into the channel, as described for the willow in Fig. 11 would be beneficial. This technique can be applied to trees and shrubs elsewhere on the river too.

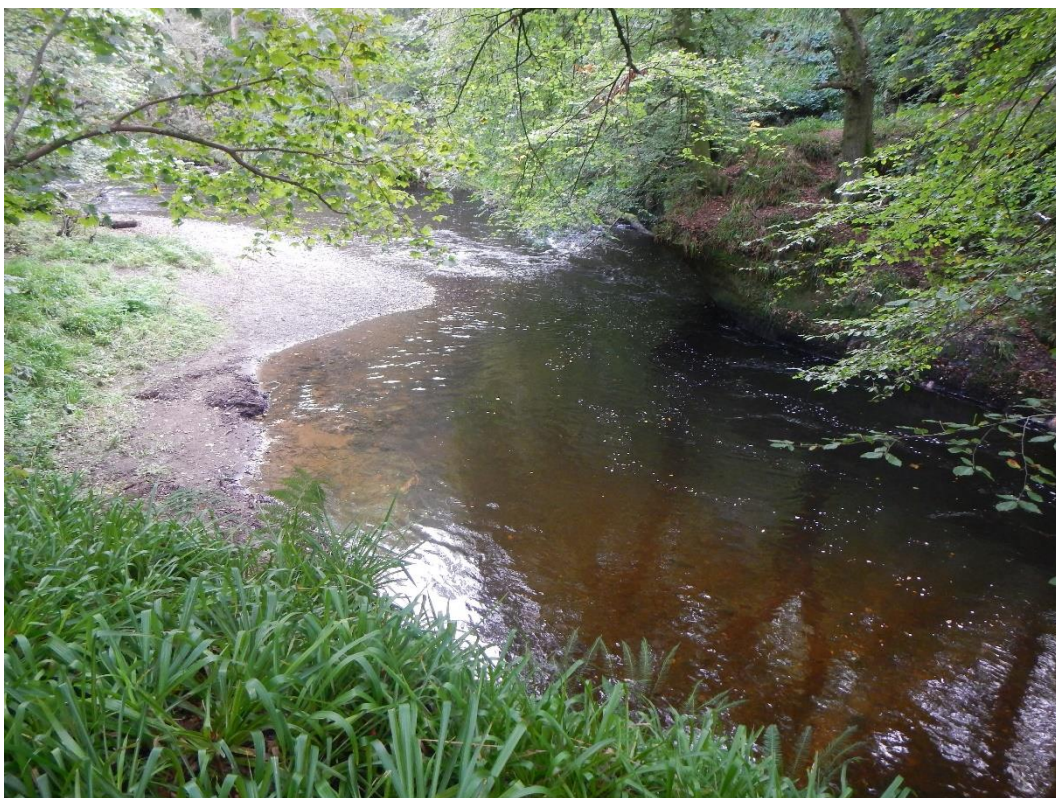
Upstream of Vicar's Bridge, the river flows through a wooded gorge, with a strong bedrock influence upon the character of the channel (Fig. 12). Being more naturally defined, and left alone to develop, habitat there is of a naturally high quality. In most cases where anthropogenic impacts (farming, infrastructure, channel maintenance etc.) are absent, simply leaving an upland river alone and allowing the habitat to develop naturally is all that is required and will deliver the best results. Having more shaded, wooded sections of the river is important in regulating water temperature and provides good fishing opportunities, even on the hotter, brighter days.

Figure 12. Looking upstream into the gorge section: naturally unkempt rivers provide great, natural habitat. It is often resisting the urge to try and alter them that is the hard part.

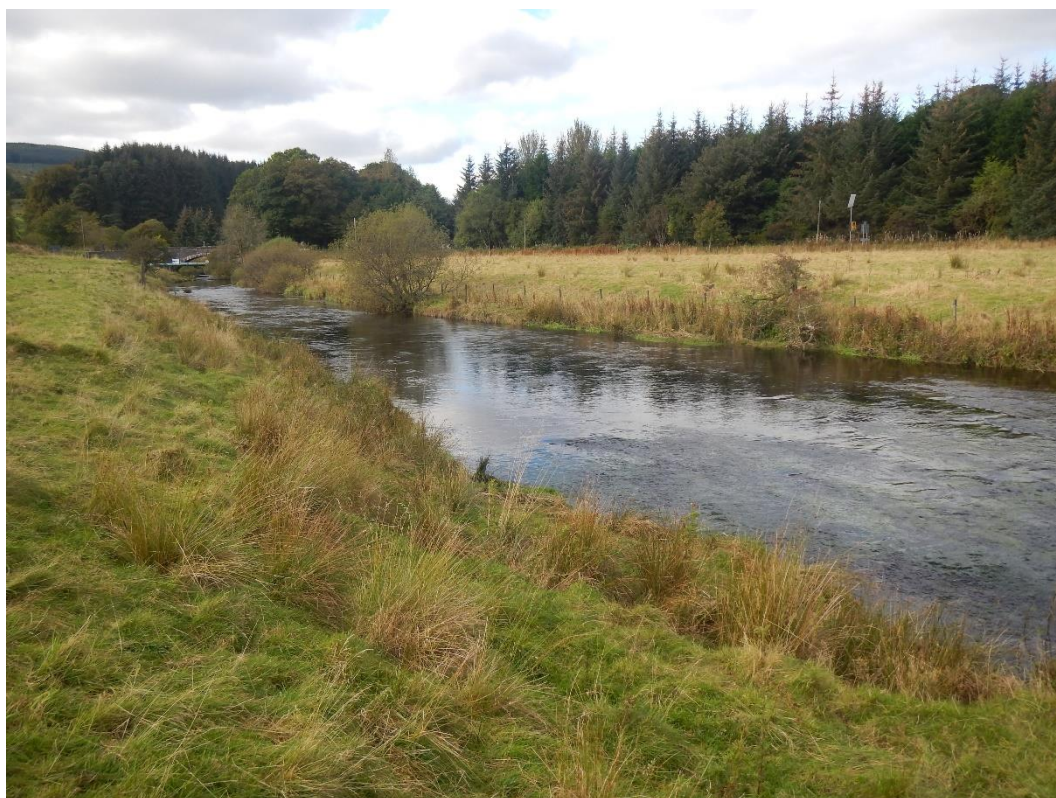
The upper sections visited were downstream, then upstream, of the fish farm at Yetts o' Muckart (NO 00966 01986). Downstream of the fish farm and A91 road bridge, livestock have open access to the RB of the river. Grazing pressure is suppressing the diversity of vegetation and preventing tree regeneration. Correspondingly, the reach is relatively open. The buffer fenced LB supports a greater diversity of vegetation and higher quality habitat for a range of invertebrates and other wildlife. The willow shrubs that have established there are almost certainly a result of the long-term livestock exclusion as willows are preferentially browsed by livestock (particularly sheep) wherever access is allowed. Ideally the RB should be buffer fenced here (and anywhere else livestock have access), to allow more of the natural vegetation and trees to establish (and be planted where lacking). Small enclosures along the bank could potentially facilitate areas of planting and/or tree and vegetation regeneration but would be less beneficial than a full buffer strip. Bankside enclosures and fences that meet the river (e.g. drinking bays) are susceptible to flood damage and the perimeters are more easily browsed, so complete livestock exclusion from the watercourse with alternative watering (mains water, or pasture, solar or ram pumps) is always preferable, with maintenance of any invasive species like Himalayan balsam undertaken. The relatively straight, steep channel in this area is predominantly glide and riffle, although the narrower areas and bends do create some deeper water habitat suitable for adult fish and the riffles provide plenty of opportunities for fry and parr (Fig. 13).

Figure 13. The fields downstream of the fish farm have open livestock access which is suppressing tree and vegetation regeneration that could be addressed with buffer fencing.

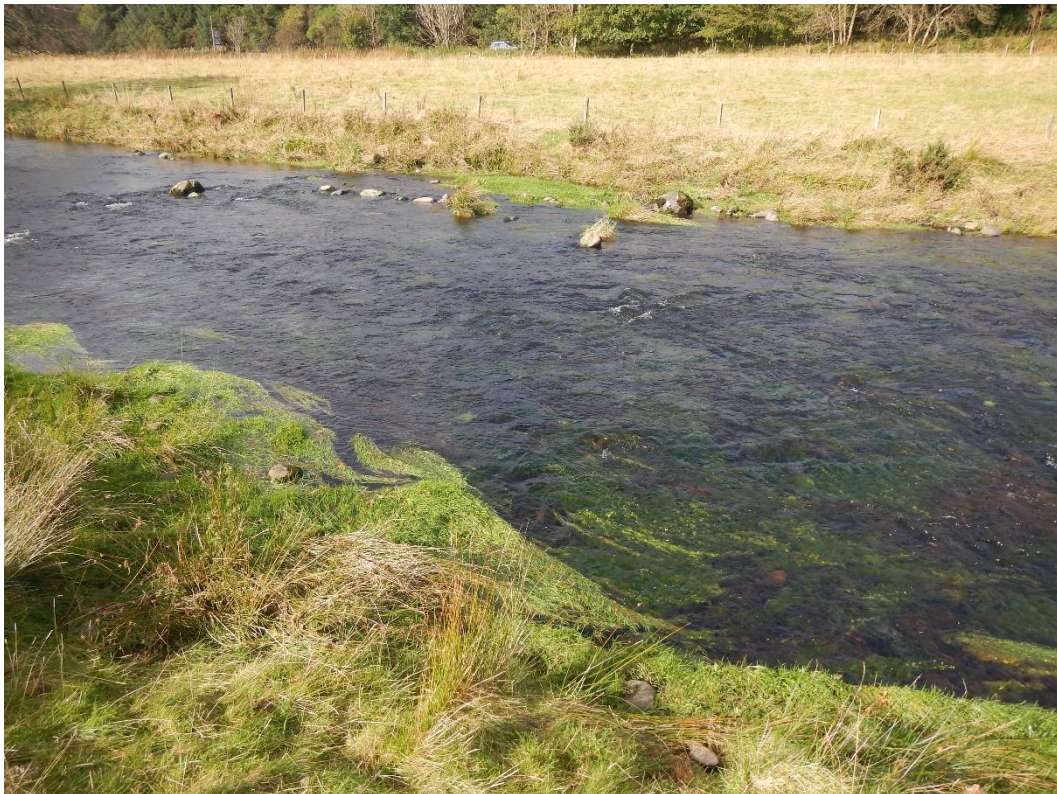
Moving upstream, it became apparent that there is a significant increase in the abundance of aquatic weed downstream of the fish farm outflow (Fig. 14), with very little observed upstream (Fig. 16). Increased weed growth is not necessarily an issue (providing it doesn't become excessive). It will provide habitat for fish and invertebrates, but the suspected increased nutrient input facilitating the weed growth should be monitored - it is to be hoped that the Scottish Environment Protection Agency (SEPA) are doing so. DAA could also undertake invertebrate monitoring, ideally at representative sites upstream and downstream of the fish farm, along with other sites throughout DAA waters (such as upstream and downstream of the sewage treatment works), to build a baseline of the river's invertebrate populations, what is present, and to identify if and when changes occur, which could potentially highlight an issue. The Anglers' Riverfly Monitoring Initiative (ARMI) by the Riverfly Partnership (www.riverflies.org/rp-riverfly-monitoring-initiative) is a great way of doing this.

Figure 14. Good quality juvenile salmonid habitat in the shallower riffles. Aquatic weed offers additional habitat, but its proliferation should be monitored as a potential indicator of excess nutrients in the river (especially in light of less growth further upstream).

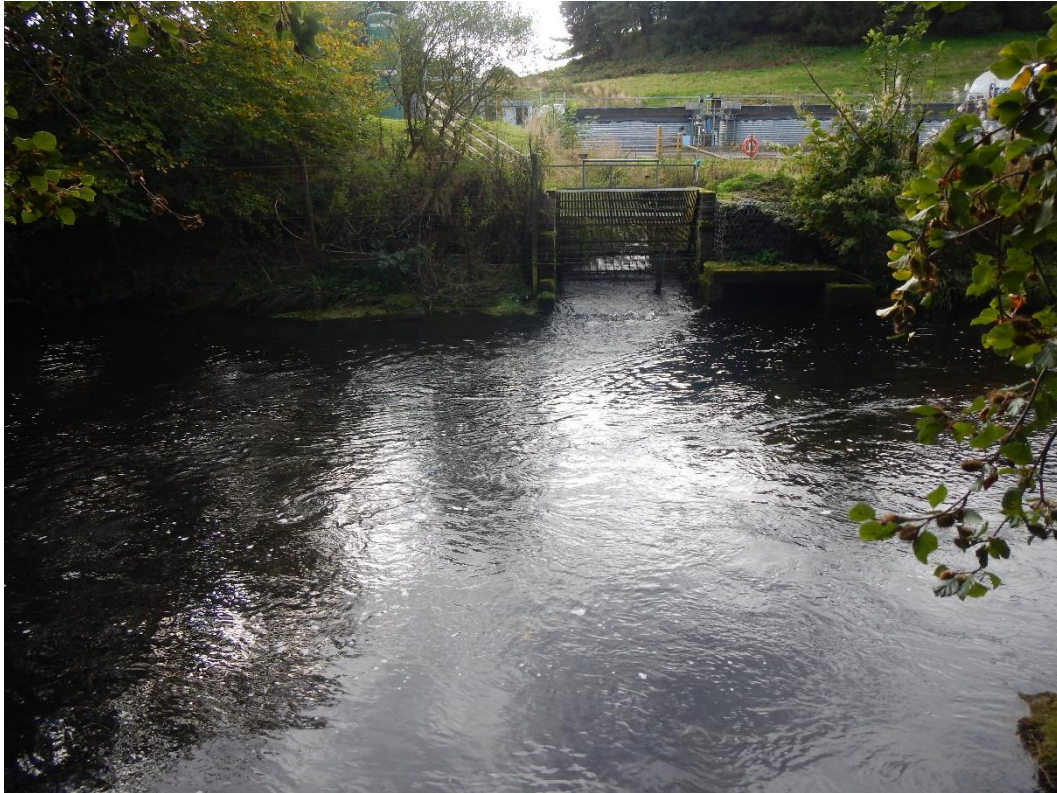
The fish farm outlet appears to be well screened for larger fish (Fig. 15), but as this is believed to be a juvenile rearing unit it will be important that there are also much finer screens within the farm to prevent fry from escaping and potentially polluting the genetic integrity of the River Devon salmon population. Screening systems can always fail, and as the site is upstream of impassable falls, it is worth being vigilant for juvenile salmon escapes (particularly around the outflow) and reporting them if they occur.

Figure 15. The outlet to the salmon rearing unit. The coarse screen should prevent the escape of larger fish, but much finer screening should also be in place within the farm to retain juveniles.

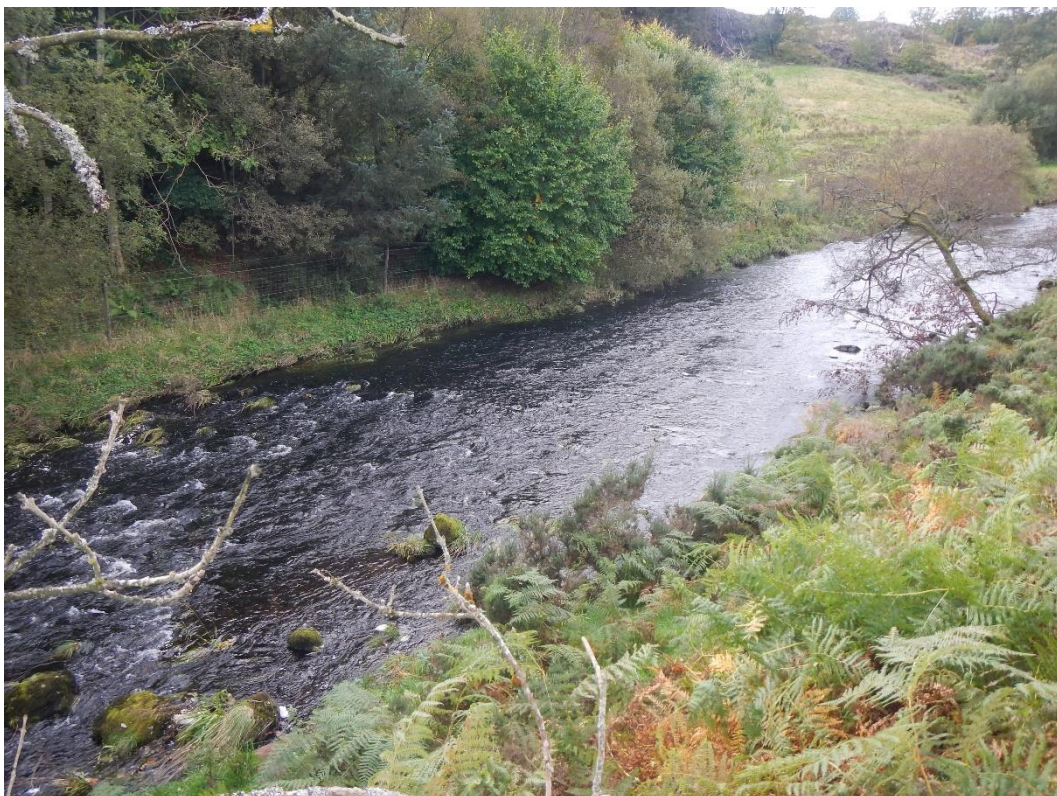
Figure 16. Upstream of the farm there is a distinct reduction in the abundance of aquatic weed, with hardly any observed. This may be indicative of increased levels of nutrient entering the system in the section downstream facilitating the growth.

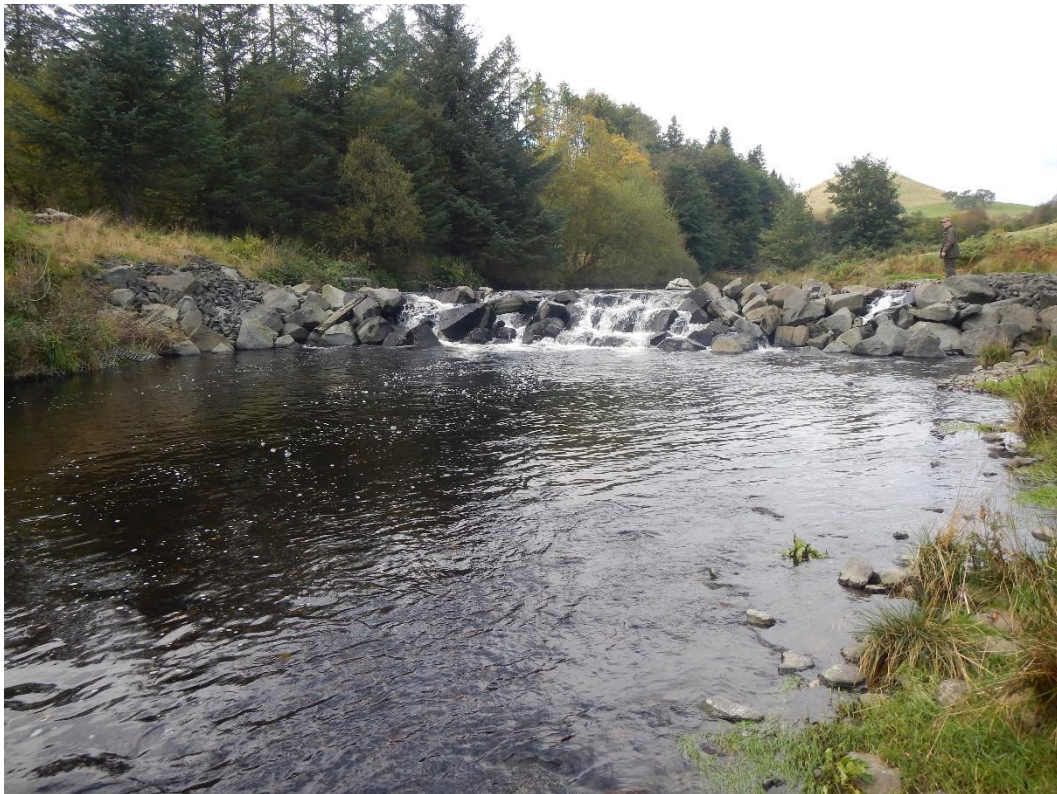
Water for the fish farm is provided by a large weir (NO 00819 02155) that interrupts sediment transport and impounds the river for some distance upstream. The weir is a major barrier to fish passage, symptomatic of the lack of regard for resident trout migration within river systems. The reservoir a short distance upstream also limits habitat availability and quality. Trout could potentially ascend the c.1.5m boulder weir in certain conditions, but it greatly limits access to the habitat upstream. Fish delayed upstream and downstream of the weir (depending upon which direction they are attempting to move) will also be more susceptible to predation, so it is important to ensure good availability of in-channel structure in these areas.

Figure 17. The weir that feeds the fish farm is likely to be impassable by fish in most flows.

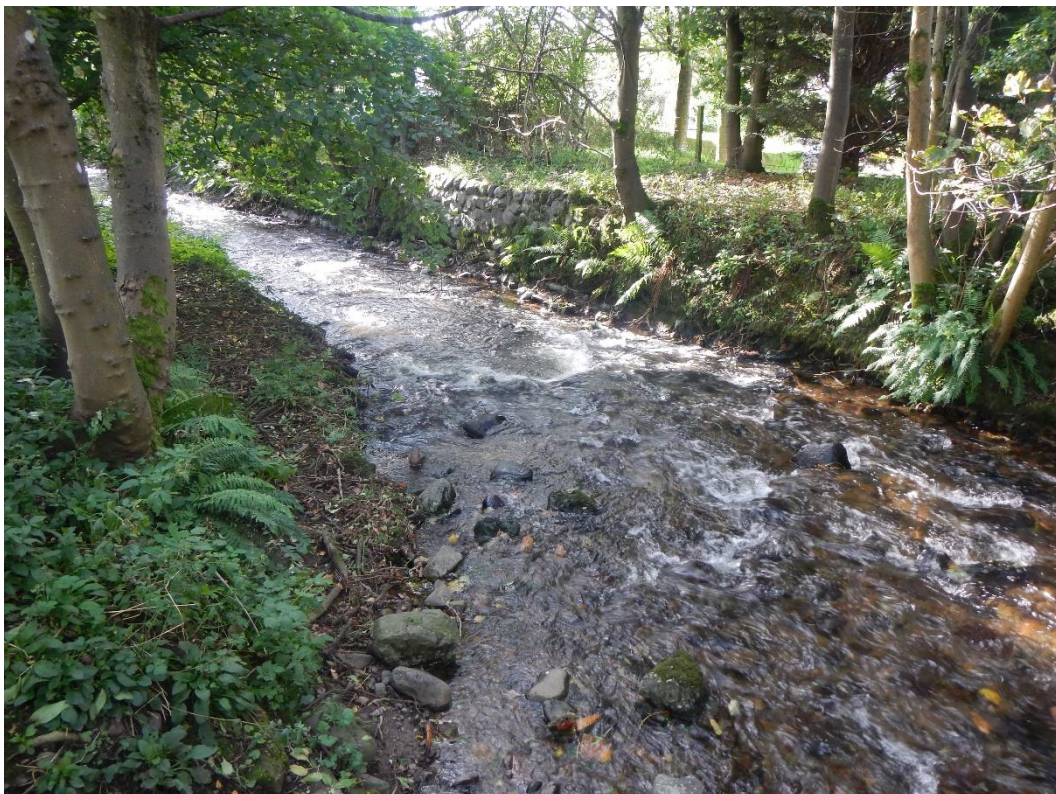
Dollar Burn (in Dollar) was also visited to assess an obstruction and the general habitat quality. Being artificially straightened, the burn is incised, steeper, more uniformly shallow and fast flowing than it should naturally be. It provides some potential salmonid spawning and juvenile habitat but lacks deeper pools and refuge for fish (particularly for juveniles) from high flows (Fig. 18). Deliberate removal of woody material from the channel by locals exacerbates the issue. These issues mean that fish are likely to run the burn immediately prior to spawning and leave immediately after, rather than residing within pools on the burn around spawning time as they might do ordinarily. This increases the importance of free access so that larger adult fish can utilise the artificially restricted spawning window.

Figure 18. Some good fry and smaller parr habitat is provided by Dollar Burn, but habitat for larger parr and adult fish is limited owing to the uniform, steep, shallow water conditions.

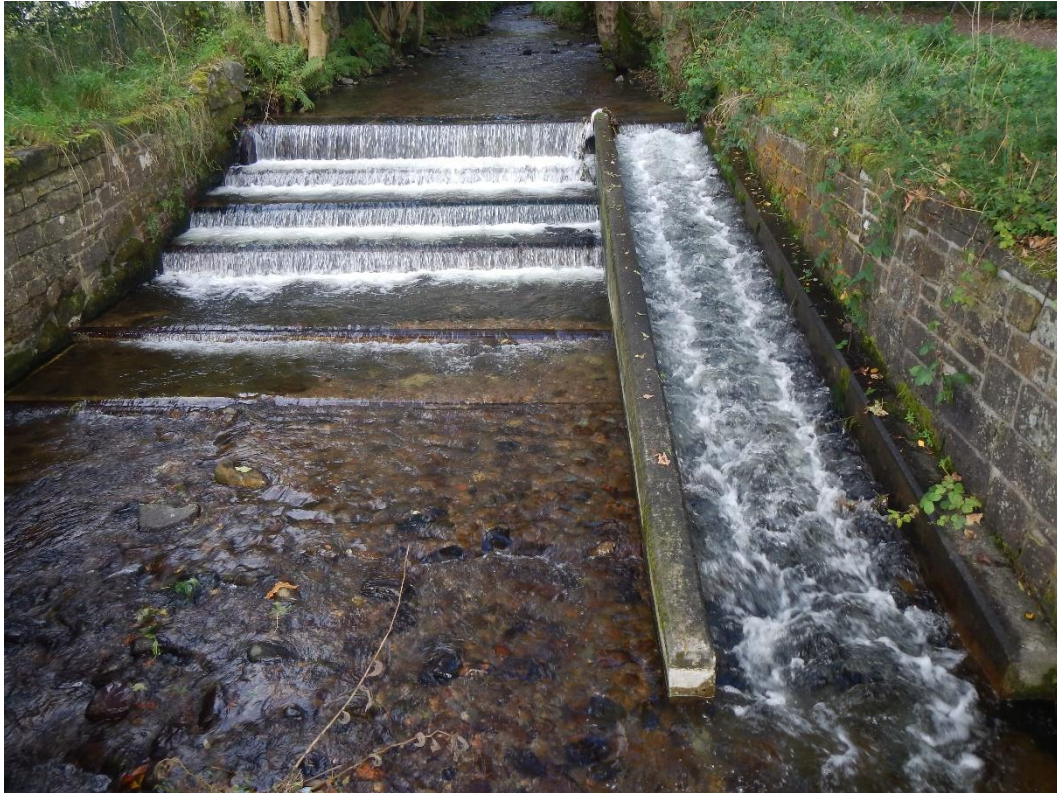
Unfortunately, an old weir on the burn creates a notable obstruction (Fig. 19). The steps of the weir are banded to create pools, but the height of each step and the size of the pools greatly limits their use to upstream migrating fish. In addition to the pools on the weir, a more modern Larinier, bottom baffle pass has been installed to the LB side of the weir in an attempt to aid fish passage. However, there are several flaws in the design and/or installation of the pass that severely limit its efficacy.

The limitations of the site (e.g. height and length of the weir) mean that to achieve an appropriate gradient the pass extends past the downstream extent the weir. This reduces its attraction to fish as there is a good chance that they will follow the majority flow past the entrance of the pass, taking them upstream to the weir. This is an unfortunate site limitation and would have been hard to overcome without instead extending the pass upstream of the weir. More concerning is the fact that the upstream end of the pass does not even extend to the level of the weir crest, failing to effectively pass the obstruction (Fig. 20). The result being a thin film of water over a vertical step onto a baffle, which is well outside the design parameters for this type of pass and creates very poor conditions for upstream fish passage, practically negating the value of the pass at most flows. Several measures could be taken to improve fish passage at this location (see Recommendations).

Figure 19. Looking upstream at the weir, with stepped pools and a poorly installed fish pass to the LB side (right of shot).

- Creating a notch into the weir crest at the upstream end of the Larinier pass. This notch should extend down to level with the base of the uppermost baffle, so as not to negatively impact upon the hydraulics of the pass.

- To maintain an appropriate flow volume down the pass, lowering the crest of at least part of the remaining weir is likely to be required to maintain the same flow split between the two channels (assuming that the flows were calculated accurately for the original installation).

- Rather than lowering the height of the entire weir crest, it may be more beneficial to create notches into the weir steps. As a minimum, this could be done to the crest but would also be beneficial if undertaken to the other steps, at alternating sides, to deflect the flow pathway from one side of the weir to the other (Fig. 23). This would increase the distance the water has to travel, thereby decreasing the overall gradient of the flow pathway over the weir. This would slow the water along the steps, impounding the water though the notches and slowing the velocity. The slower flow within the pools would also allow fish resting areas between the notches (where increased exertion is required). N.B. undertaking this may be dependent upon the exact structure and integrity of the weir. An alternative could be to notch the uppermost step and raise all but a narrow notch on the lower steps (creating a similar alternating baffle).

- The baffles of the Larinier pass also appear to be trapping bed material supplied from upstream. It would be worth maintaining the baffles free from this debris, to optimise their efficiency.
