Advisory Visit

River Devon

01/10/2019

Undertaken by Gareth Pedley (WTT)

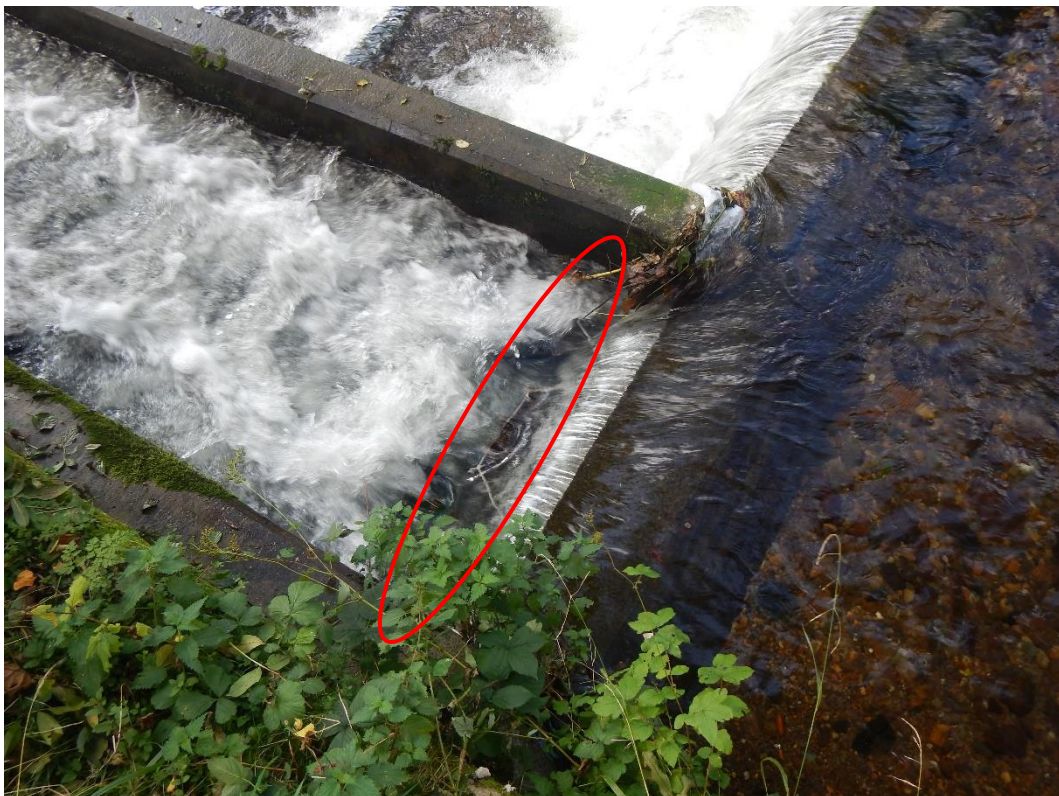
Figure 20. The significant step and thin film of water, with air cavity behind, falling onto the top baffle of the Larinier pass (red ellipse) creates a major obstruction to further upstream progress for fish.

- Creating a notch into the weir crest at the upstream end of the Larinier pass. This notch should extend down to level with the base of the uppermost baffle, so as not to negatively impact upon the hydraulics of the pass.

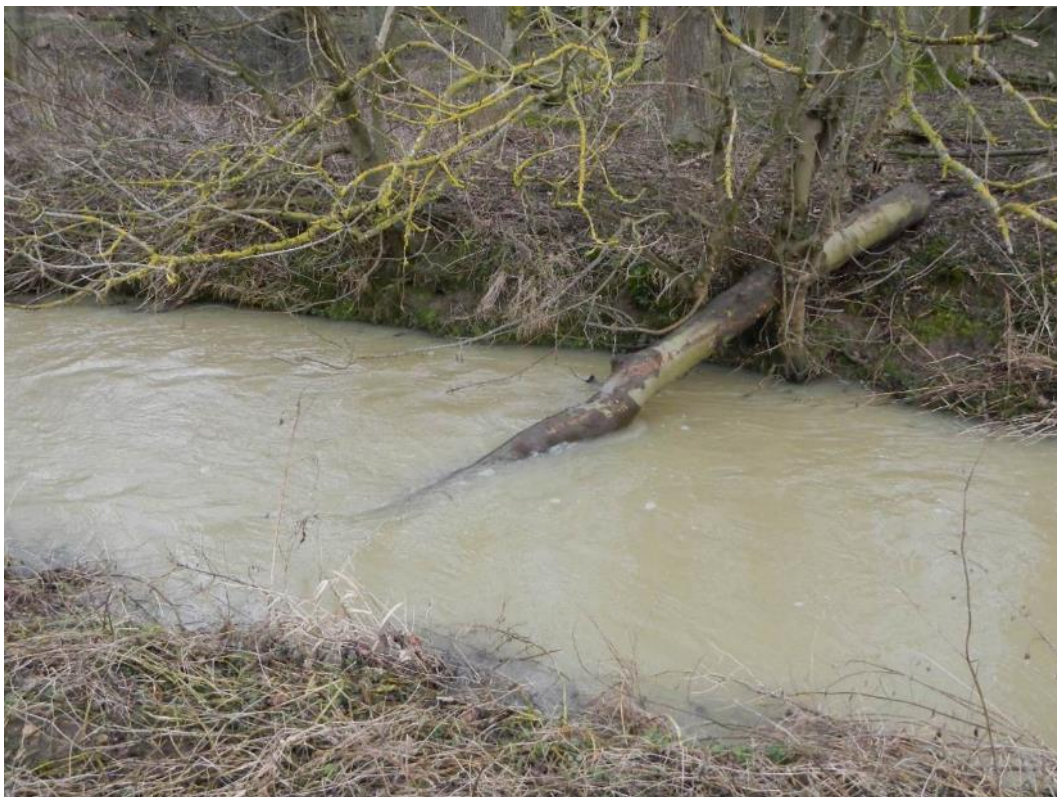
Figure 21. A lodged flow deflector – the technique can be used with a single trunk or branch (primarily to increase scour) or a multi-branched limb (to create greater flow dissipation and more in-channel structure). The elevated butt end (bank end) reduces the potential for detrimental bank scour (usually associated with d/s deflectors) as a through-flow is maintained along the bank.

As highlighted in Fig. 21, where multiple trees or stems are present, one can be cut (with no significant detriment to the overall canopy or other habitats) and lodged between two or more others. This would complement the recommended tree work in the area around the sewage treatment works discharge (Fig. 8), utilising the material won from the coppicing.

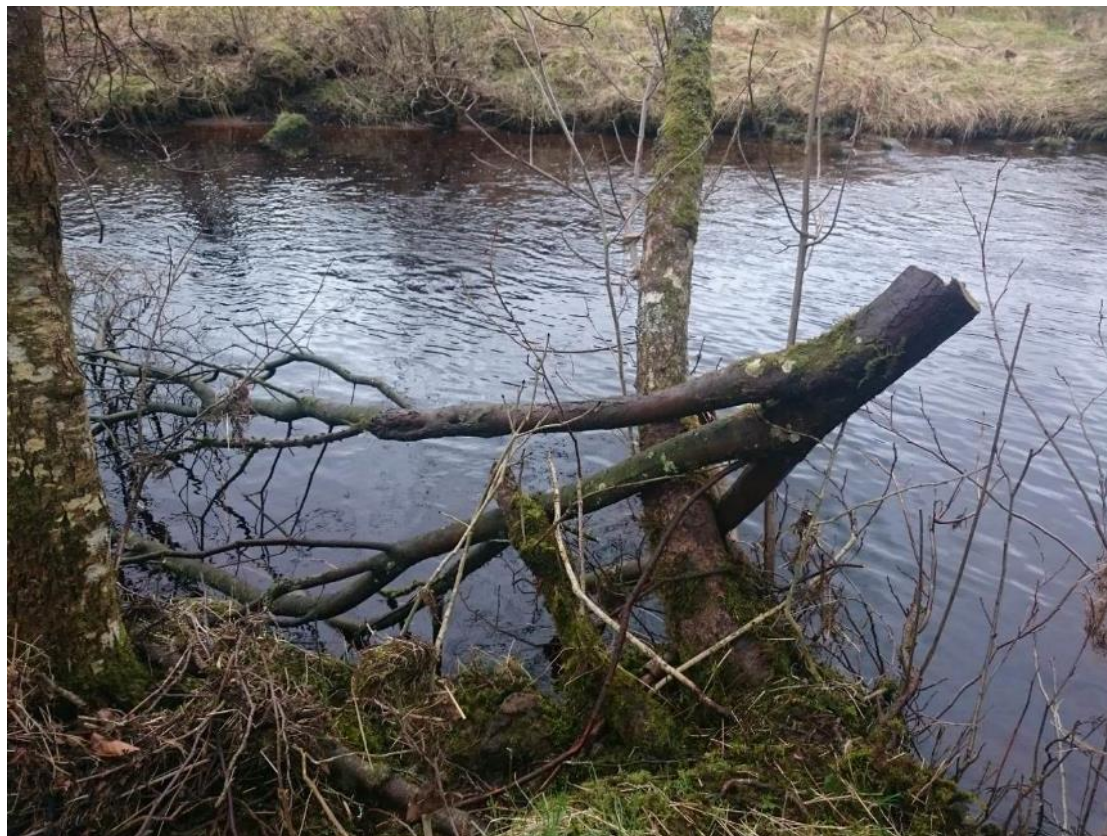
Figure 22. A medium-sized piece of lodged woody material which is securely anchored in place against an upright tree.

An alternative, nature-like, lodged flow deflector method that could be applied is equally simple but involves hooking one branch of a multi-stemmed branch around an upright tree (Fig. 22). The example uses a medium-sized branch, but any size of branch or tree can be employed providing the anchor tree is stable and of sufficient size.

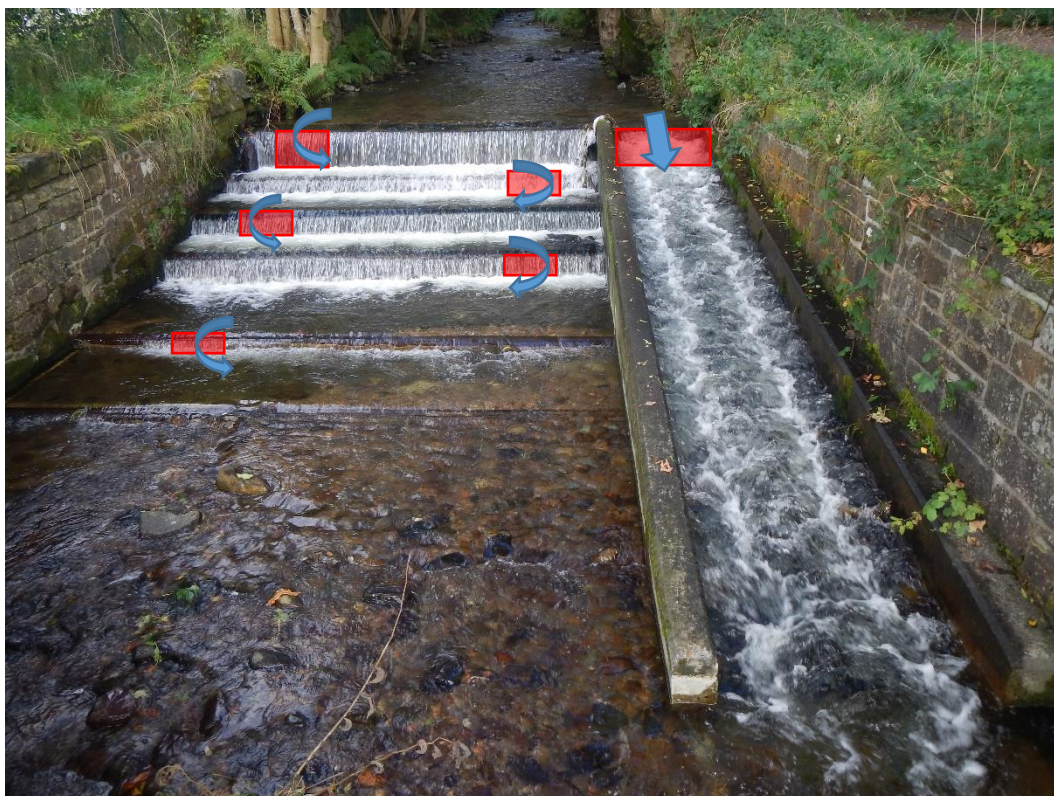
Figure 23. Possible notching of the weir that could reduce the potential for super-charging the Larinier pass with flow by the required crest lowering at the upstream end. This option would actually improve the passability of the weir via an alternative route, delivering multiple benefits. The blue arrows signify the potential flow pathway though the notches.

- Rather than lowering the height of the entire weir crest, it may be more beneficial to create notches into the weir steps. As a minimum, this could be done to the crest but would also be beneficial if undertaken to the other steps, at alternating sides, to deflect the flow pathway from one side of the weir to the other (Fig. 23). This would increase the distance the water has to travel, thereby decreasing the overall gradient of the flow pathway over the weir. This would slow the water along the steps, impounding the water though the notches and slowing the velocity. The slower flow within the pools would also allow fish resting areas between the notches (where increased exertion is required). N.B. undertaking this may be dependent upon the exact structure and integrity of the weir. An alternative could be to notch the uppermost step and raise all but a narrow notch on the lower steps (creating a similar alternating baffle).
